ROAD SAFETY AUDIT

Route 9 (Main Street/Bridge Street) From West Street and
Elm Street to Market Street and Hawley Street

Northampton, MA

April 16, 2020

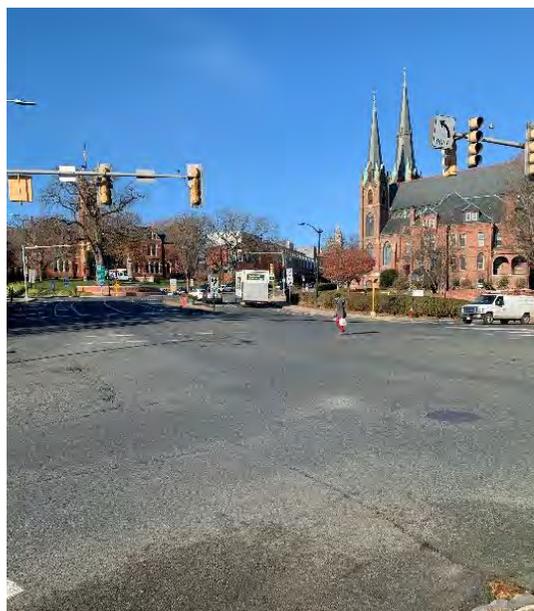
The wide geometry of the roadway was a common topic of discussion among RSA Members. The RSA team noted that the wide roadway contributes to irregular traffic patterns for motorists and long crossings for pedestrians (see Figure 11). The Main Street corridor typically ranges from 62 to 92 feet in width. The corridor operates as a two-way, two-lane roadway with only a double centerline provided, which causes confusion and discomfort for many, especially those who are unfamiliar with the area. The lack of lane delineation within the wide roadway as well as the overall geometry also contributes to vehicle weaving, last-minute position changes, vehicle turning movement issues, and pedestrian safety issues. As a result, a significant number of crashes along the corridor were side-swipe (18.5%) and angle (27.5%) crashes. However, RSA members also noted that the confusion associated with lack of defined lanes may help to slow down traffic as drivers are more cautious navigating the roadway.

Figure 11: Pedestrian crossing on the wide intersection of Main Street at State Street and New South Street

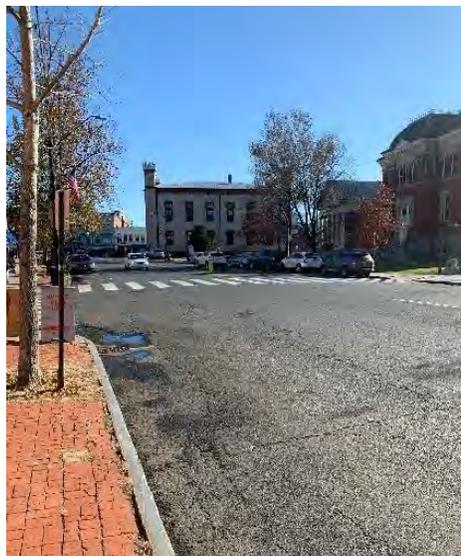
Many sections of the corridor were noted to have missing or fading pavement markings (see Figure 12). Stop bars, lane lines, lane designations markings, and crosswalks were all noted to be missing or faded at numerous locations along the corridor. This was discussed as a source of confusion for drivers and a safety issue for pedestrian visibility.

Figure 12: Missing travel lane pavement markings

- Reinstall missing or faded pavement markings to reduce vehicular confusion and improve vehicular and pedestrian safety. Consider updating the markings with polyurea or recessed thermoplastic markings.

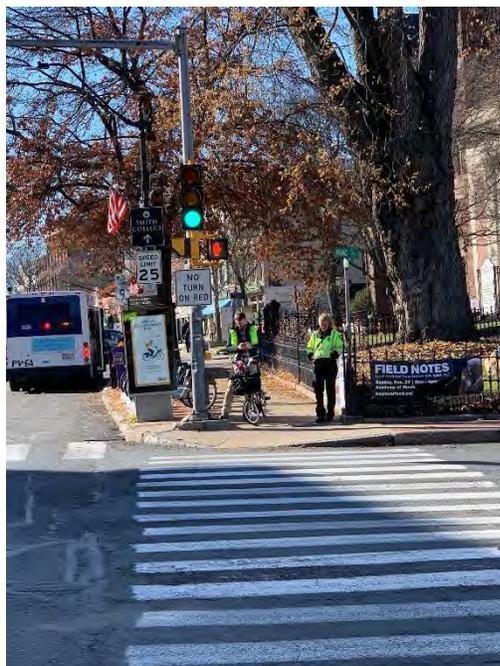
Figure 13: Countdown timer missing on pedestrian signal

Existing pedestrian signals do not have Flashing Don't Walk countdown timers (see Figure 13) and accessible pedestrian signals (APS) were missing at the vast majority of signalized crossings.

- Replace outdated and old signal equipment, where necessary.
- Evaluate signal head locations according to lane locations and relocate to appropriate locations to increase signal visibility. Evaluate the need to upgrade all traffic signal infrastructure and assess mast arm capacity.
- Install retroreflective backplates on signals to improve signal visibility.
- Update signal equipment with APS push buttons and pedestrian countdown timers for all signalized intersections to increase safety for pedestrians.
- Evaluate the use of camera detection rather than loop detectors, some of which are not functioning.

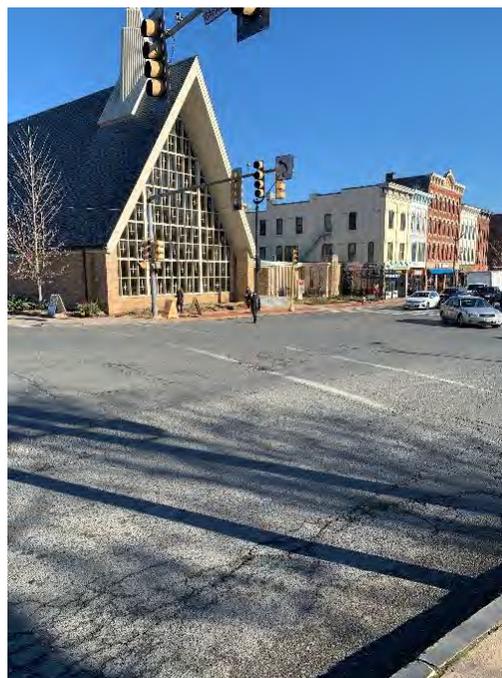
A total of eleven crashes (6.6%) involved pedestrians at unsignalized marked crosswalks throughout the corridor. Audit members noted that long crossings (see Figure 14), restricted sight lines, and low lighting were contributing factors to pedestrian crashes at unsignalized crosswalks. The excessive wait times for pedestrians throughout the corridor were also discussed as contributing to impatience and jaywalking at signalized crosswalks. As previously mentioned, inconsistent pedestrian signal phasing (concurrent or exclusive) throughout the corridor was noted as a source of pedestrian confusion. Continental crosswalks are provided throughout the corridor, however audit team members noted that several crosswalks were faded. Curb ramps are generally provided, however many were not ADA-compliant and were missing tactile warning panels.

Figure 14: Pedestrian walking beyond the long crosswalk lines on Main Street and State Street

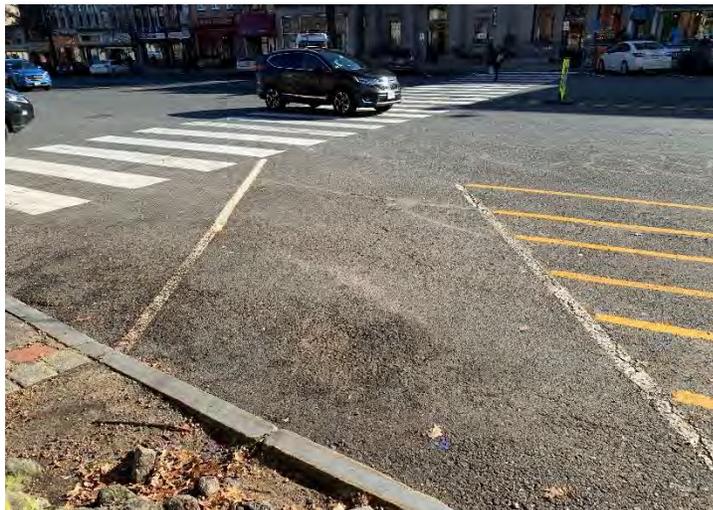
Figure 15: Parking space too close to crosswalk

Limited lighting was also mentioned as a cause of concern for pedestrian visibility, particularly for the side street approaches. Audit members mentioned that parking spaces too close to crosswalks contributed to the problem of limited sight lines as well (See Figure 15). Additionally, overhead lighting was observed above Main Street, however lighting is not provided over the minor street approach crosswalks. This may have contributed to the four (36.3%) of the eleven crashes involving pedestrians on a crosswalk took place at night.

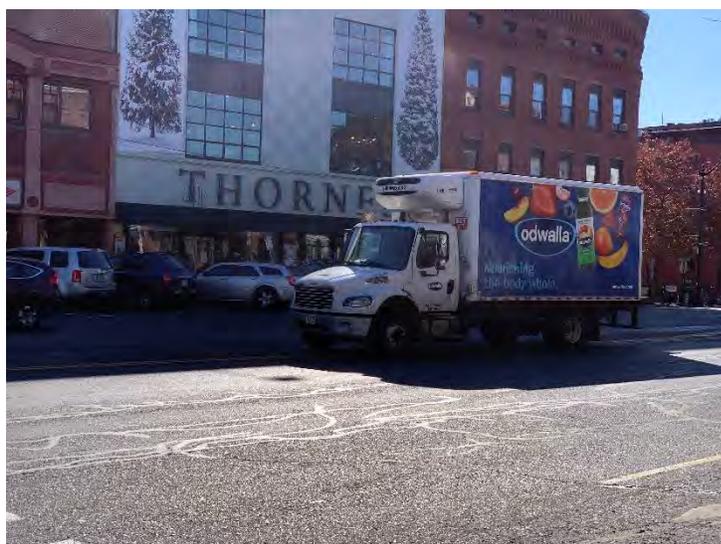
Figure 18: Trucks observed to be loading/unloading in the middle of roadway

Dedicated loading zones are not provided throughout the corridor and contribute to curbside challenges for commercial loading and unloading. Furthermore, truck loading and unloading is generally unavailable behind Main Street buildings. As a result, trucks use the center of roadway to load and unload (See Figure 18). Audit team members noted that majority of the commercial loading occurs during peak traffic times. Trucks were also noted to parallel park behind the angled parking, which blocks in vehicles using the angled parking and limits visibility for vehicles backing out of angled parking.

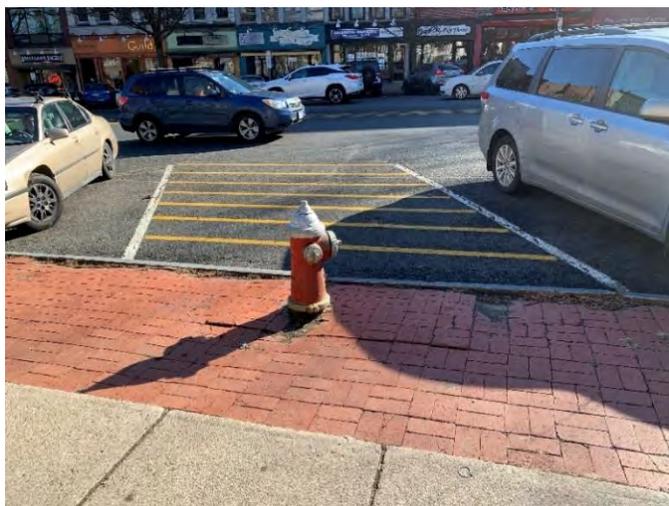
Figure 19: Parking spaces within 10 ft of a hydrant

Parking stall widths and angles are inconsistent throughout the corridor. In addition, multiple parking spaces were located within 10 feet of a hydrant, which is against state law (See Figure 19). On-street parking was also noted to be located too close to crosswalks, which restricts visibility between motorists and pedestrians within the crosswalk. While there were some ADA parking spaces, audit members mentioned that the utilization of the spaces may need to be evaluated. Residents and retailers have the perception that parking along the corridor is limited, however the lack of wayfinding to parking garages is contributing to this perceived notion.

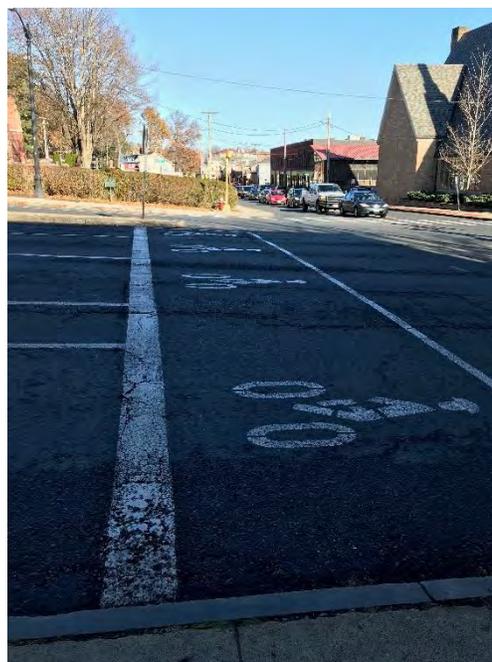
Audit team members also noted that the New South Street stop bar was set back, limiting available sight lines and visibility primarily for the right-turning vehicles. Furthermore, the Main Street eastbound bicycle turning queue boxes at State Street were not painted green and were too wide spanning several travel lanes (See Figure 21).

Figure 21: Bicycle turning queue boxes at Main Street on eastbound State Street are not painted green

- Reinstall the Main Street bicycle queue box with appropriate green paint and continue bicycle lane broken white line through intersection.

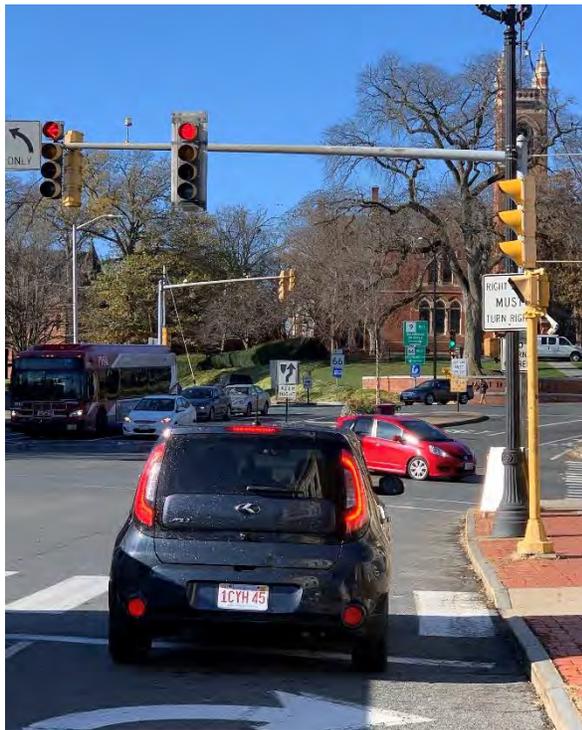
Figure 23: "No turn on red" sign blocked by a pole and "Right turn must turn right" sign at Main Street westbound approach to State Street

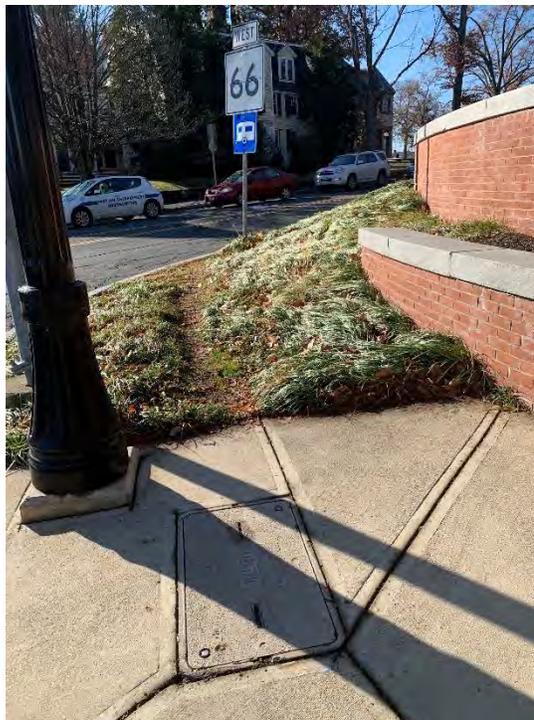
Figure 24: "Goat path" observed on the corner of Elm Street at West Street

- Evaluate feasibility of providing a designated crossing with appropriate safety enhancements across Elm Street, either at West Street, Main Street or midblock.
- Evaluate feasibility of installing sidewalks from the west corner of Elm Street at West Street along the north side of West Street to provide safe pedestrian accommodations to the on-street parking along West Street.
- Evaluate the feasibility of relocating the diagonal Main Street crosswalk to provide a shorter and safer crossing. Recommendations included: a crosswalk west of State Street or across Elm Street.
- Restripe the diagonal crosswalk with continental-style crosswalk markings (the standard for all other downtown crosswalks).

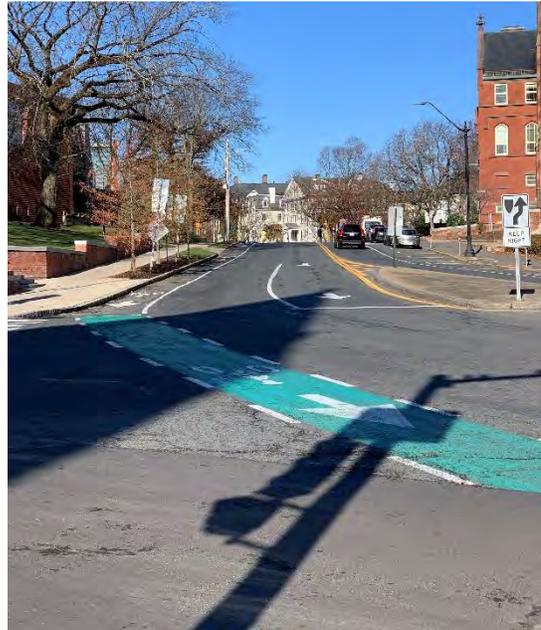
Figure 25: Bicycle lane on Elm Street which terminates at State Street

- Consider reinstalling queue box with green paint.
- Consider providing a two-stage turn box in front of the crosswalk at the northbound West Street approach to facilitate turns for less-experienced bicyclists.
- Consider realigning the Elm Street travel lanes and bicycle lane.
- Consider adding vertical delineation to help keep vehicles from encroaching on the bicycle lane.

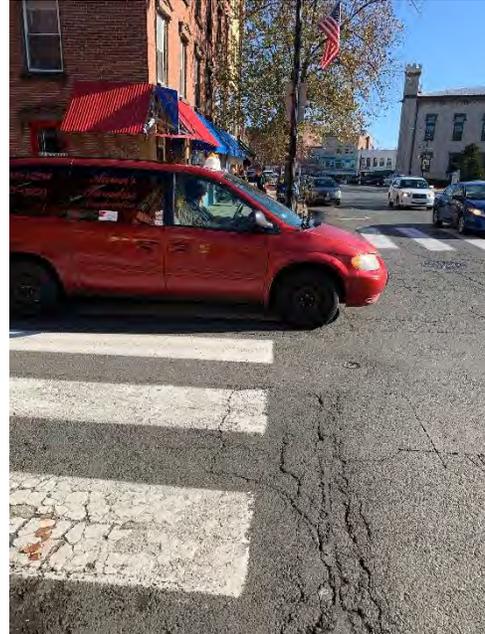
The wide geometry at this intersection was cited as a challenge for southbound vehicles turning left onto Main Street. When turning left from Masonic Street onto Main Street, vehicles must find a gap and navigate this wide turn against the wide travel lanes (See Figure 26). Furthermore, audit members noted that left-turning vehicles are typically focused on waiting for the queued traffic to clear on Main Street and often overlook pedestrians within the Main Street crosswalk. Five of the reported crashes (33.3%) out of 15 total crashes at this intersection involved a left-turning vehicle from Masonic Street. Out of the five, three (60%) crashes involved a pedestrian within the crosswalk. Some members of the audit team also noted that since the closure of the Cracker Barrel Alley, Masonic Street has seen more traffic as it is now the only access to the Masonic parking lot from Main Street. Others noted, however, that vehicles approaching from the east often use Center Street and there are no traffic counts to support higher traffic on Masonic between Main Street and the parking lot.

Figure 26: Sight line issues for southbound vehicles on Masonic Street

- Consider restricting left turns from Masonic Street to discourage the unsafe vehicular maneuvers.
- Consider installing a center median on Main Street to restrict this movement.
- Consider reducing the roadway width to decrease the number of lanes being crossed while making left turns in and out of Masonic Street

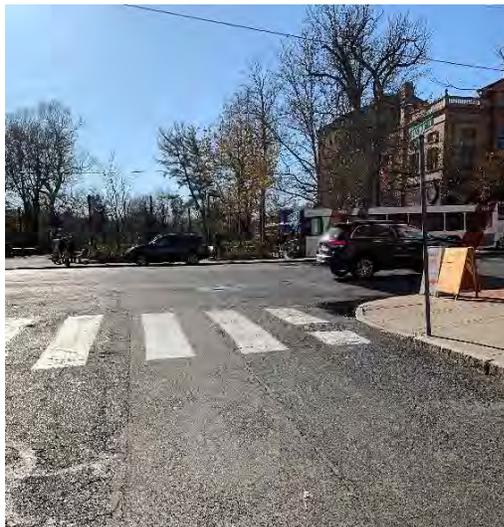
Figure 27: Missing stop bar and centerline on Masonic Street

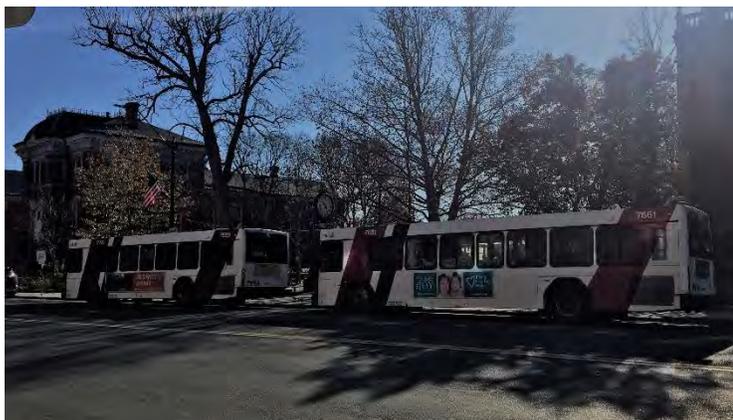
The bus stop in front of the Academy of Music and Pulaski Park was identified by the audit members as highly utilized with multiple buses serving the stop (See Figure 28). The stop has become challenging with multiple buses attempting to pull into the designated stop that provides space for only two buses. There is an on-street parallel parking space located between the front of the bus stop and the Main Street crosswalk at Masonic Street. This

Figure 28: PVTA buses stopped in front of Pulaski Park and Academy of Music

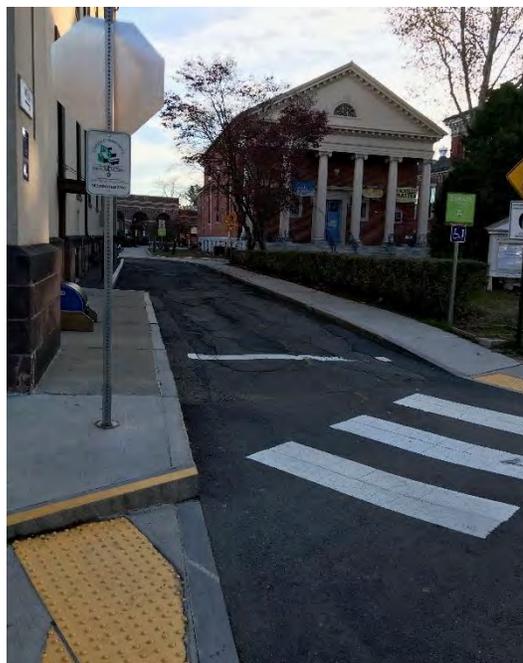
Figure 29: City Hall parking entrance with one access point for entry and exit

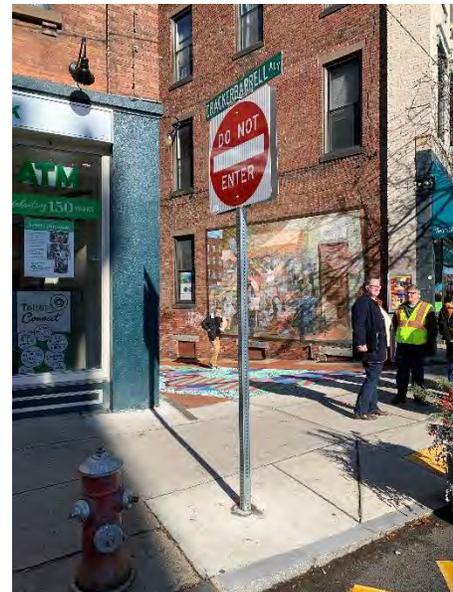
Figure 30: "Do Not Enter" sign is parallel with Cracker Barrel Alley

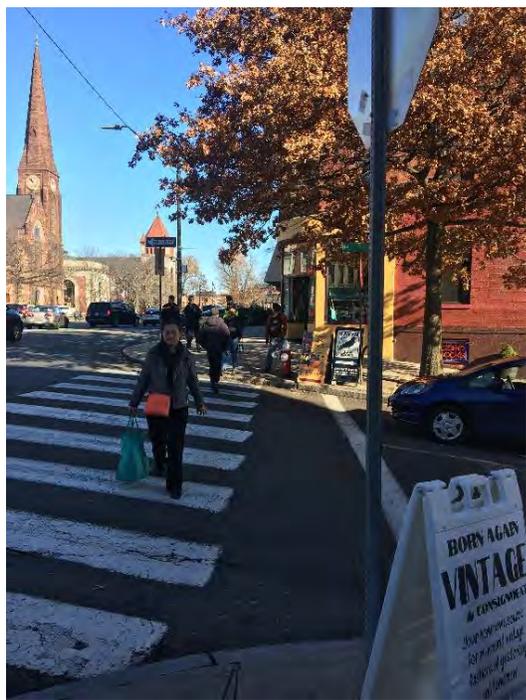
Figure 31: Steep grading observed at Old South Street

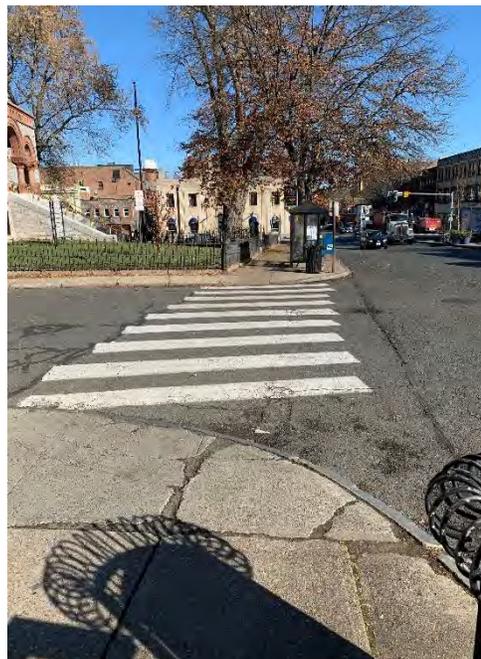
Figure 33: Gothic Street has no stop bar or centerline. No crosswalk across Main Street.

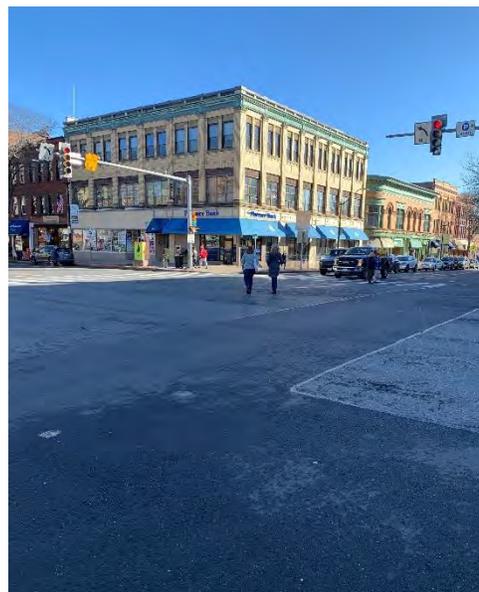
Figure 34: Pedestrians observed crossing diagonally on Main Street at King Street/Pleasant Street

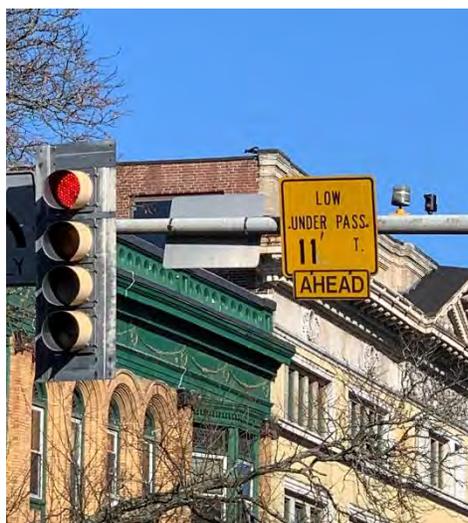
Figure 35: Low clearance sign for the railroad bridges on the mast arm was not visible

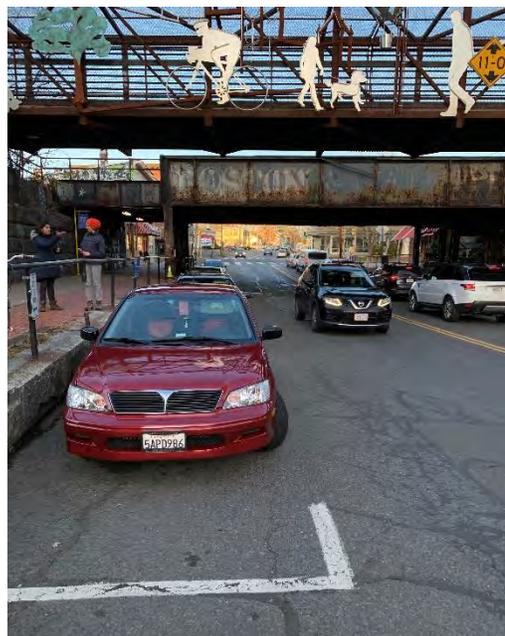
Figure 37: Parallel parking under the railroad bridges

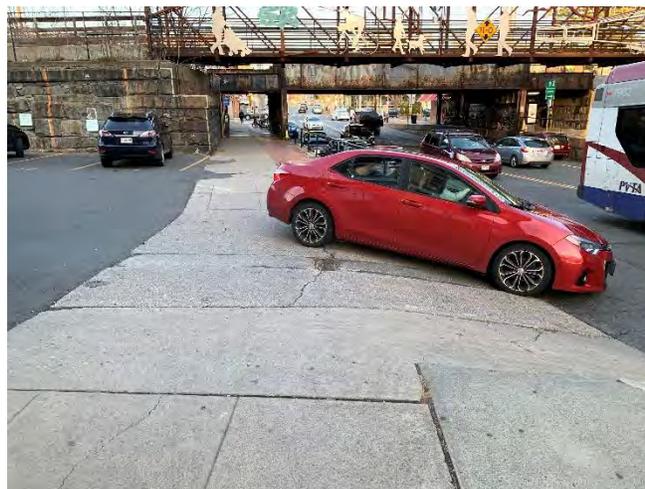
Figure 38: Driveway with steep curb cut adjacent to Main Street crosswalk at Strong Avenue

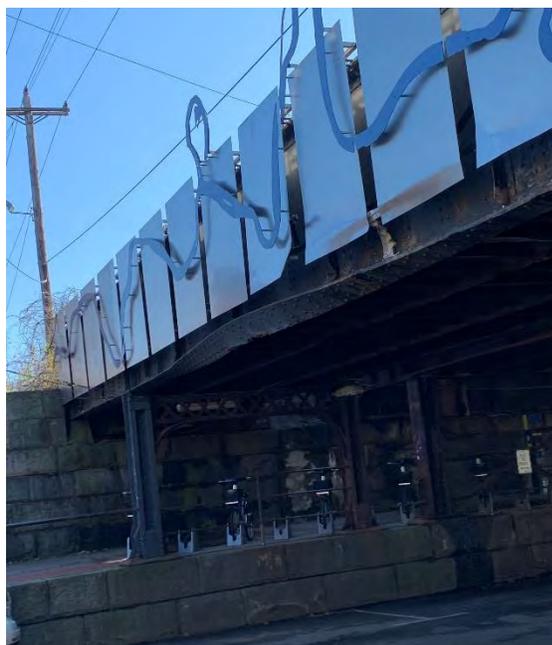
Figure 39: Railroad Bridge dented due to several truck collisions

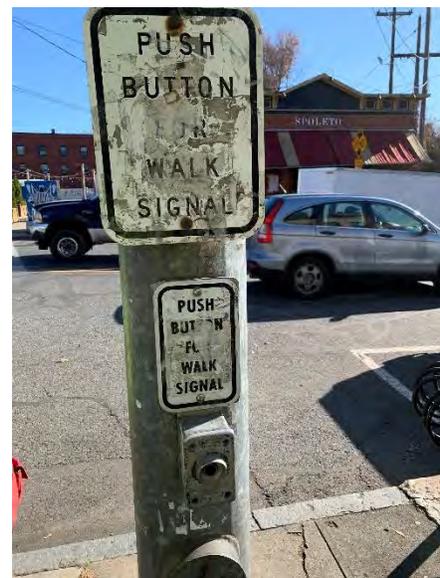
Figure 40: Outdated pedestrian push button
