ROAD SAFETY AUDIT

Route 9 (Main Street/Bridge Street) From West Street and
Elm Street to Market Street and Hawley Street

Northampton, MA

April 16, 2020

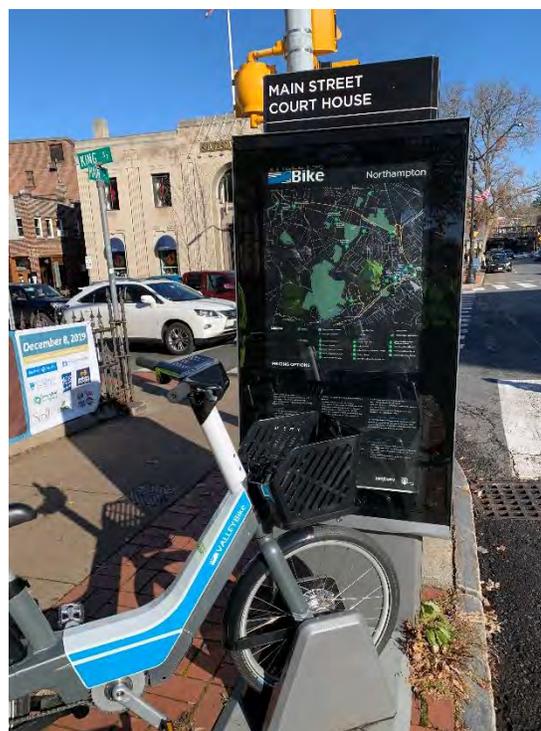
Figure 16: ValleyBike bike share location and wayfinding map

Four crashes (2.4%) reported for the corridor involved a bicyclist. With no designated space for bicyclists within the roadway, sidewalk biking is a common behavior even though it is illegal according to City of Northampton ordinance. In some instances, contraflow biking was also noted. While Valley-Bike bikeshare locations are provided along the corridor, RSA members discussed that some stations are placed within the sidewalk and limit space for pedestrians. This can pose a safety hazard for pedestrians with accessibility needs and cause queuing at sidewalks. Audit members recommended that while this audit references crash data from 2015-2017, it would be a worthwhile task to go beyond to see if any bicyclist fatalities existed in the corridor. In 2012, one bicyclist fatality was identified in the intersection of Main Street and Pleasant Street, in which the bicyclist was struck by a vehicle making a left turn from Main Street to Pleasant Street.

- Consider installing high-friction surface treatment for bike lanes especially at intersections, high-volume driveways or areas where traffic is merging to another lane and crossing the bike lane.
- Consider dedicated pavement markings for bicycles turning left from bicycle lanes including two-stage turn queue boxes at intersections.
- Add enhancements along the corridor, including MUTCD-compliant signage and wayfinding, to provide better Rail Trail connections
- Assess bicycle parking locations, styles, and supply. Consider additional bicycle parking options including corrals, bicycle storage boxes, bike racks, etc.
- Evaluate bikeshare locations to maximize pedestrian space and improve access to bicycles.

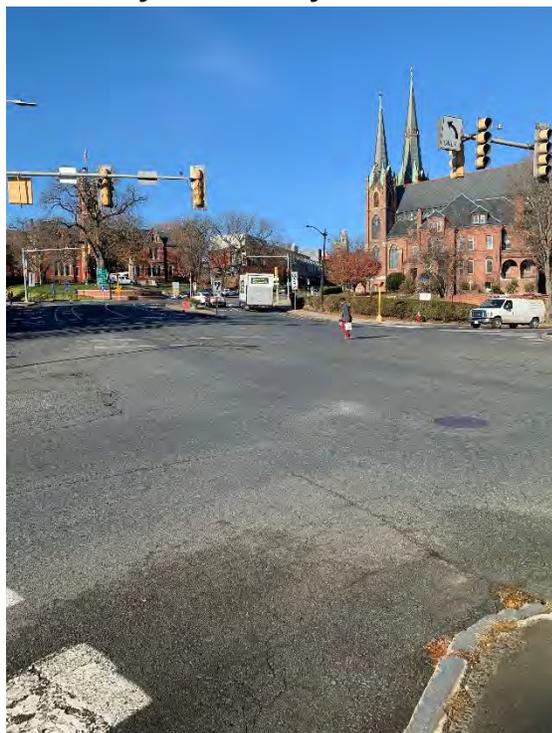
Figure 20: Pedestrian crossing across the wide intersection at Main Street and State Street

The entire intersection(s) was perceived by audit members to be too expansive (See Figure 20). The wide roadway and offset geometry complicate turning movements and may have been a contributing factor in the reported 15 angle crashes (41.7%) out of the total 36 crashes at this location. The Main Street eastbound approach consists of two thru travel lanes, but only provides one wide receiving lane without pavement markings or signage, forcing vehicles to merge within the intersection and potentially contributing to the five reported side-swipe crashes (13.9%) at this location.

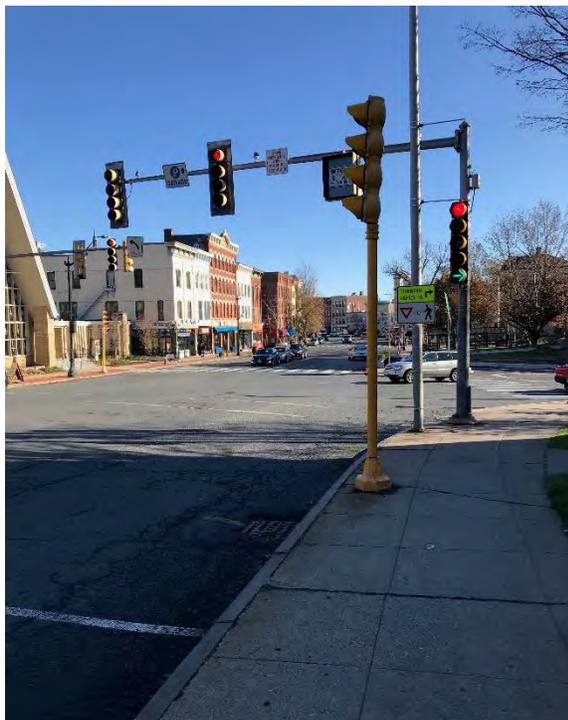
Figure 22: Traffic signal at Main Street and New South Street showing green arrow for right-turning vehicles

Signal heads are provided overhead on mast arms for the Main Street, Elm Street, and West Street approaches while the State Street and New South Street approaches have post mounted signal heads. The audit team noted several instances of signal equipment related inconsistencies. Audit team members discussed that the Main Street eastbound right-turn green signal at New South Street should have a green ball or the existing green arrow. Currently, the signal includes a green through arrow as well as a green right turn arrow. The eastbound right-turns operate protected/permmissive, being allowed to proceed with the through traffic. Team members noted that the green arrow should be changed to a green ball for this reason and that right-turning vehicles are to yield to the pedestrians crossing New South Street during the permissive part of their phase (See Figure 22). Additionally, the Elm Street westbound signal at West Street has one overhead signal serving both through and left-turn lane, with an additional post mounted signal with flashing beacons that activate when the pedestrian phase across West Street is active. It was

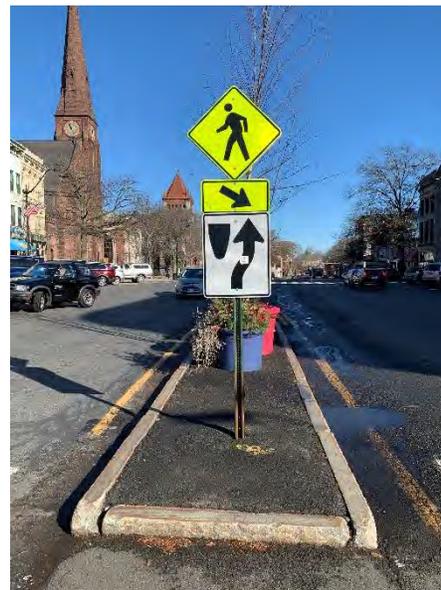
Figure 32: Crosswalk sign on the median adjacent to the rainbow crosswalk

Audit members noted that crosswalk signage was only provided at the median and the signs were missing on the ends of the crosswalk (See Figure 32).

- Evaluate feasibility of moving rainbow crosswalk closer to Old South Street intersection.
- Consider restricting parking before the rainbow crosswalk to increase pedestrian visibility and after the crosswalk to prevent vehicles from backing into the crosswalk.
- Evaluate feasibility of curb extensions to shorten the Main Street crossing and to increase pedestrian visibility.

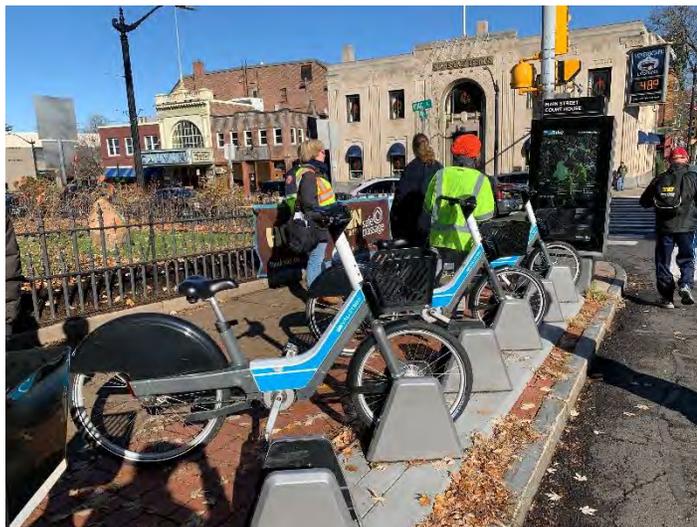
Figure 36: ValleyBike bikeshare station at the northwest corner of Main Street and King Street

Members of the audit team noted that the northwest corner of this intersection has limited sidewalk space but has a high volume of pedestrians looking to cross. That corner is also next to a well-used bus stop just west of an angled ValleyBike bikeshare station that occupies the sidewalk space at this corner (See Figure 36).

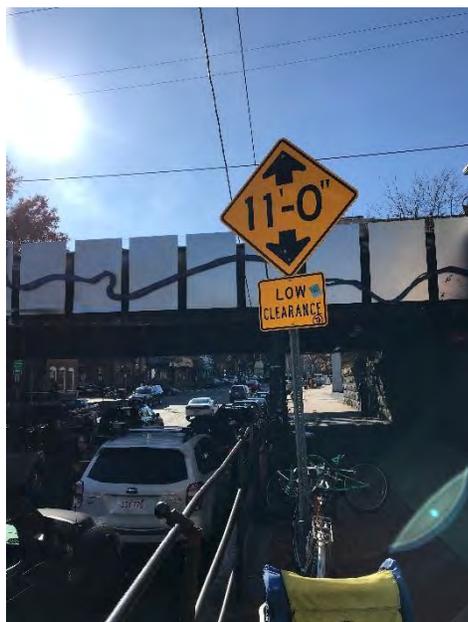
Figure 41: Bridge height restriction sign

The rail bridges overpass is located approximately 70 feet west of the intersection of Bridge Street at Market Street and Hawley Street. There is a bridge height restriction sign located on both directions along Main Street (See Figure 41). The bridge height restriction sign was noted to not have the fluorescent ambers that increase sign visibility.
