# **Florence Road Traffic Study**

**Draft Report**

**October 2007**

Prepared under the direction of the Pioneer Valley Metropolitan Planning Organization for:  
City of Northampton

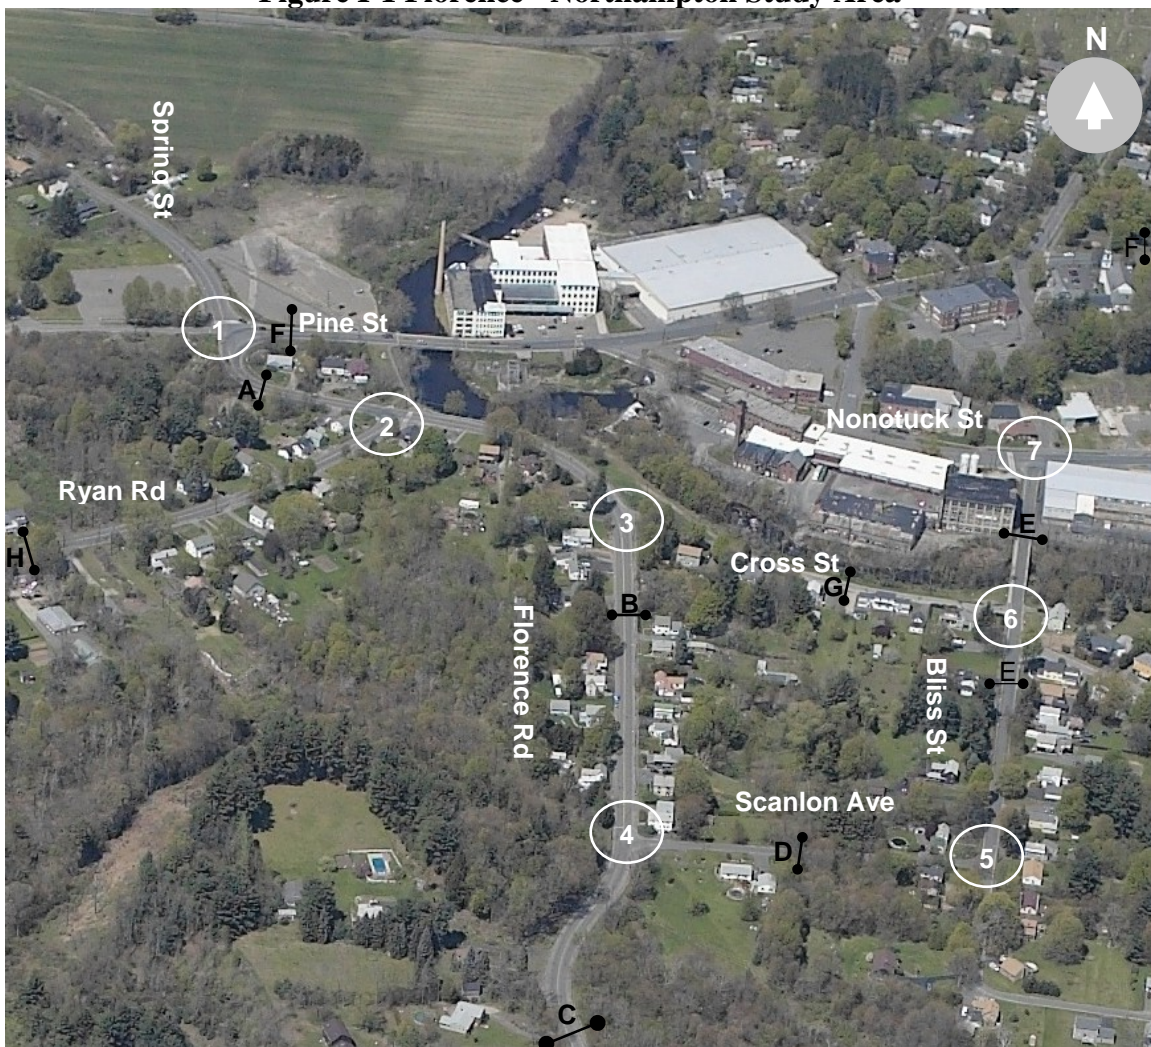
**Figure I-1 Florence - Northampton Study Area**

- ① Turning Movement Count Location
- A Daily Volume Count Location

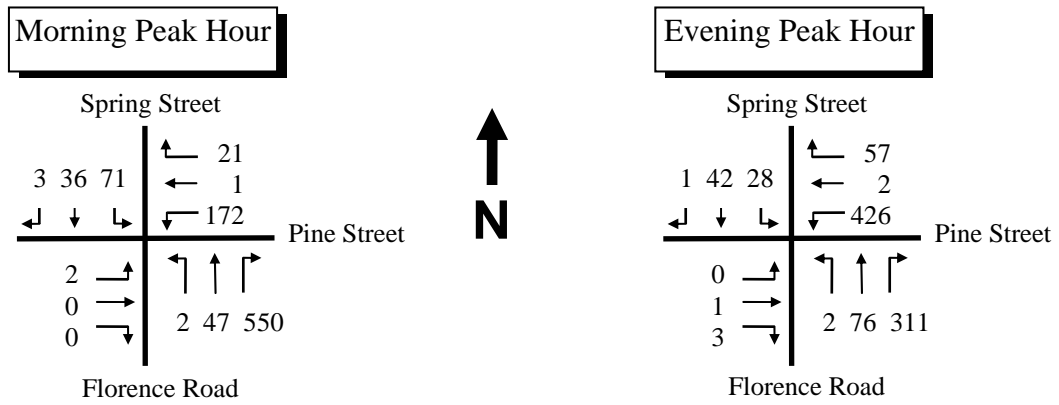
**Figure II-1 Florence Road and Pine Street Morning and Afternoon Peak Hour Traffic Volumes**

Based on the MassHighway data, traffic volumes collected during the months of April, May, and June are estimated to be higher than the annual average. Therefore, the traffic count data was adjusted to reflect average month conditions. Turning movement count data for the morning and afternoon peak hours are summarized on Figures II-1 to II-7 for the seven intersections in this study. These seven intersections include:

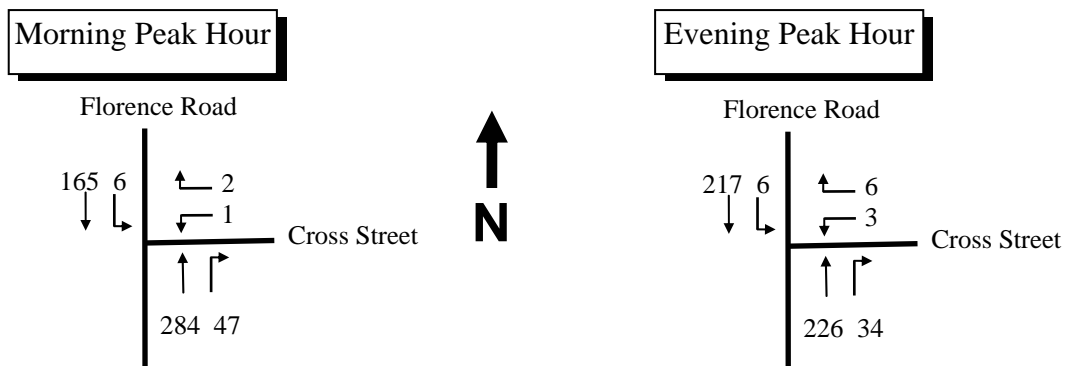
**Figure II-3 Florence Road and Cross Street Morning and Afternoon Peak Hour Traffic Volumes**

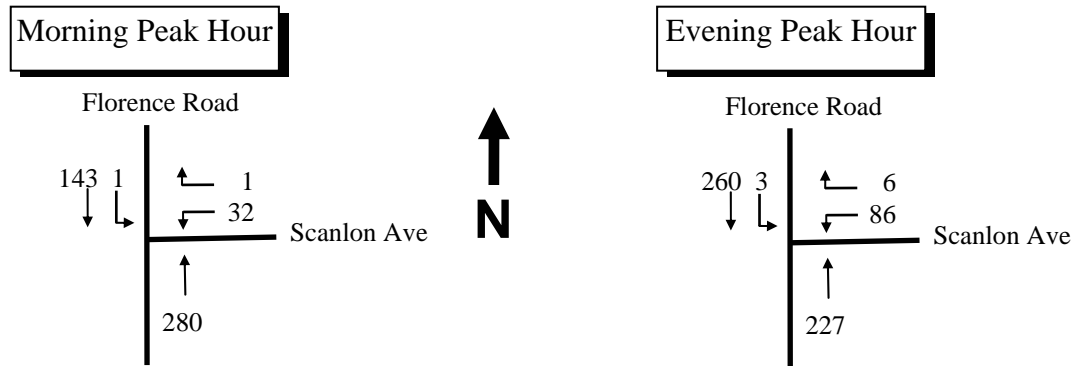
**Figure II-4 Florence Road and Scanlon Avenue Morning and Afternoon Peak Hour Traffic Volumes**

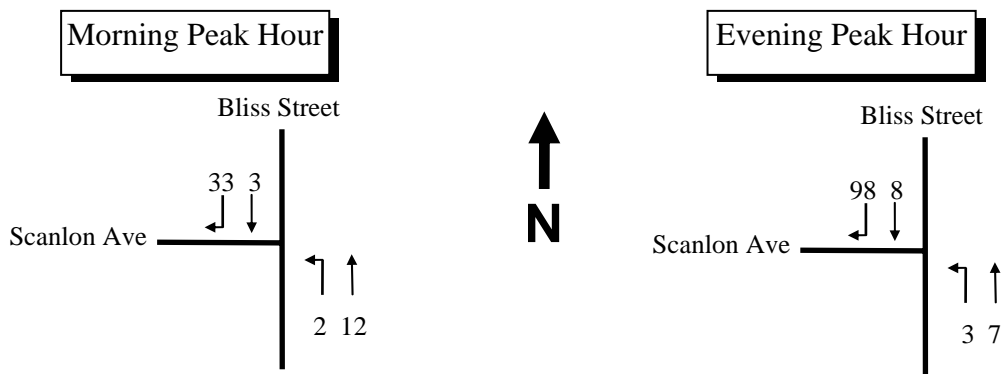
**Figure II-5 Bliss Street and Scanlon Avenue Morning and Afternoon Peak Hour Traffic Volumes**

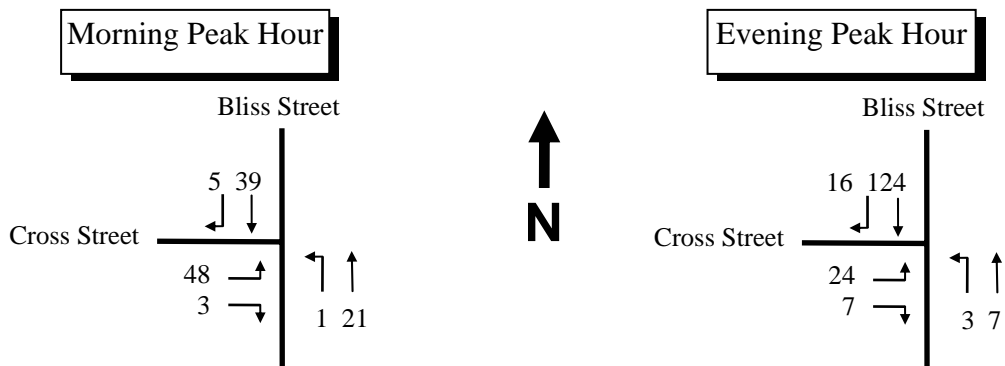
**Figure II-6 Bliss Street and Cross Street Morning and Afternoon Peak Hour Traffic Volumes**

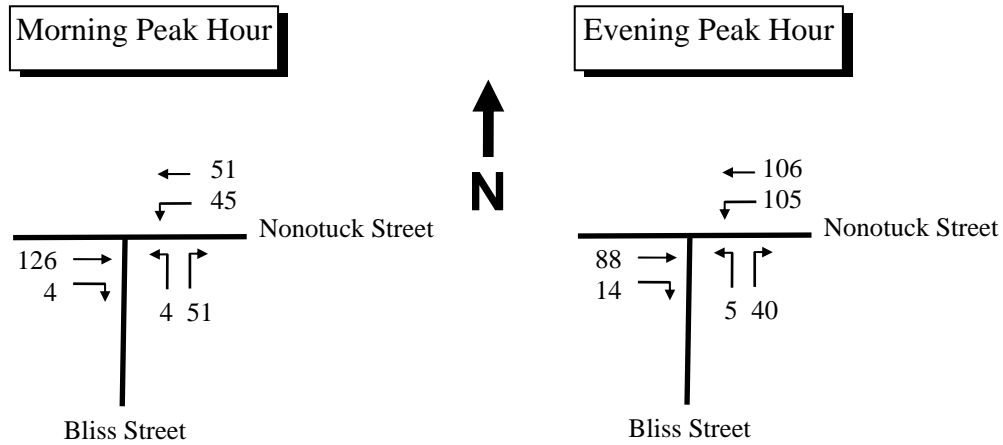
**Figure II-7 Bliss Street and Nonotuck Street Morning and Afternoon Peak Hour Traffic Volumes**
